Lower Passaic River Restoration Project

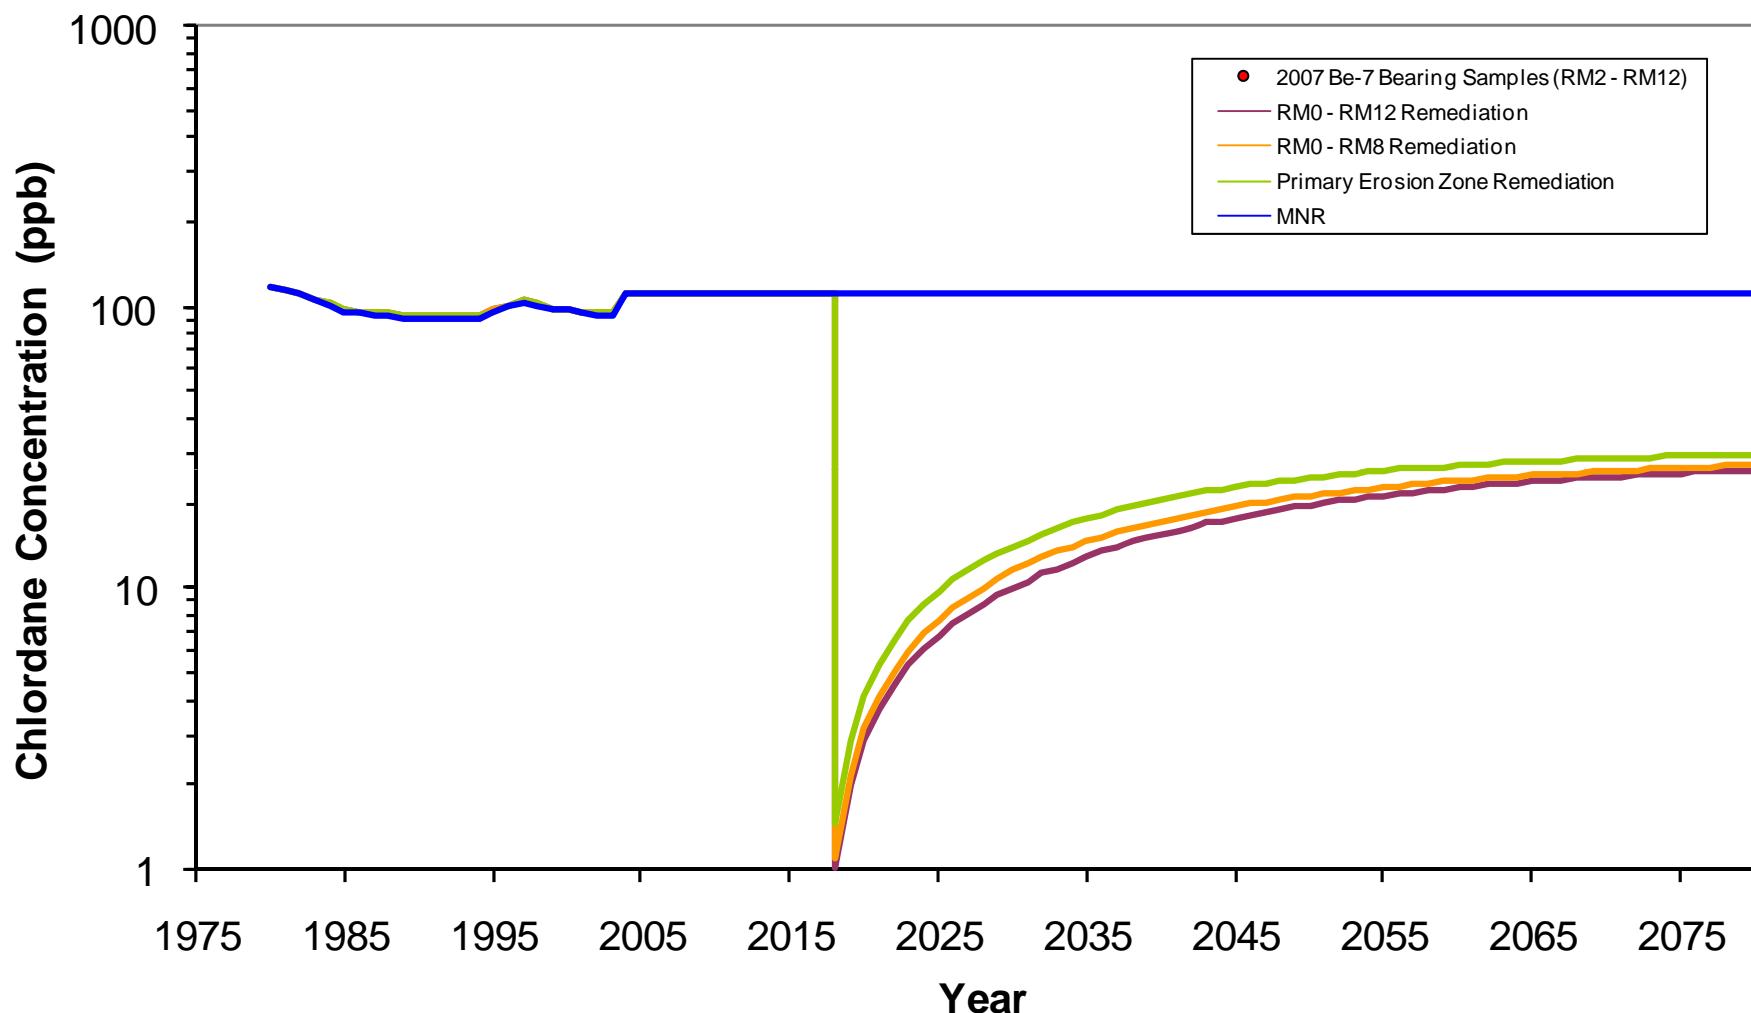
Figure 20-40

Chlordane
Comparison of Estimated Trajectories for Remediation Options for 0-6 inch
Biologically Active Layer in Capped Regions
Lower Passaic River Restoration Project

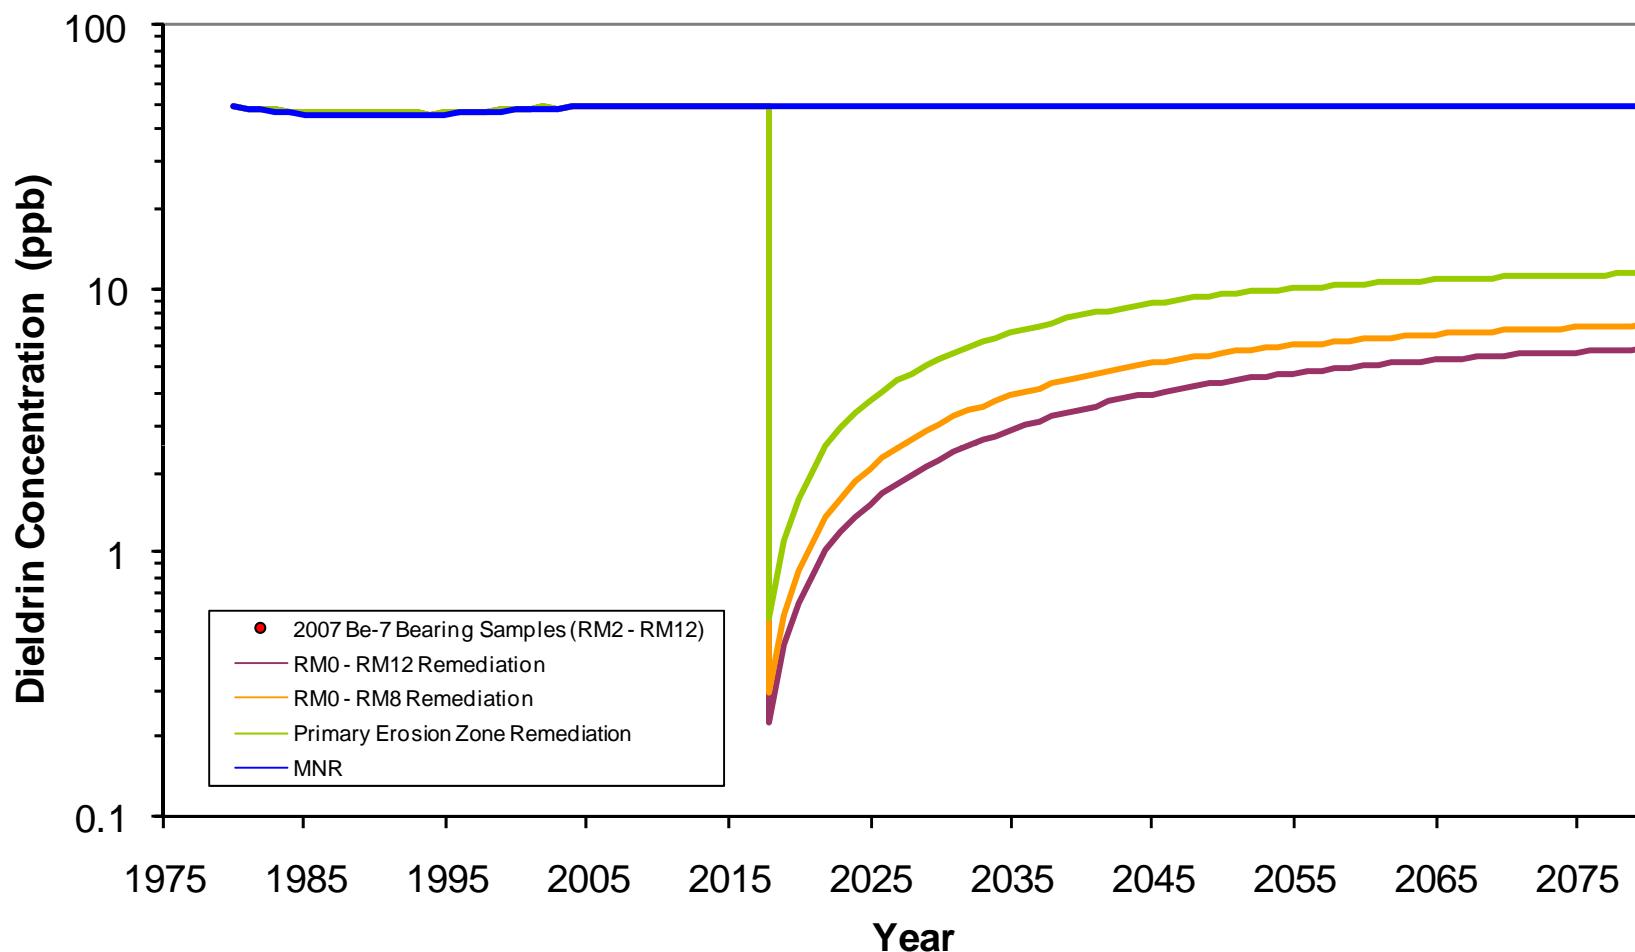
Figure 20-41

Dieldrin
**Comparison of Estimated Trajectories for Remediation Options for 0-6 inch
 Biologically Active Layer in Capped Regions**
Lower Passaic River Restoration Project

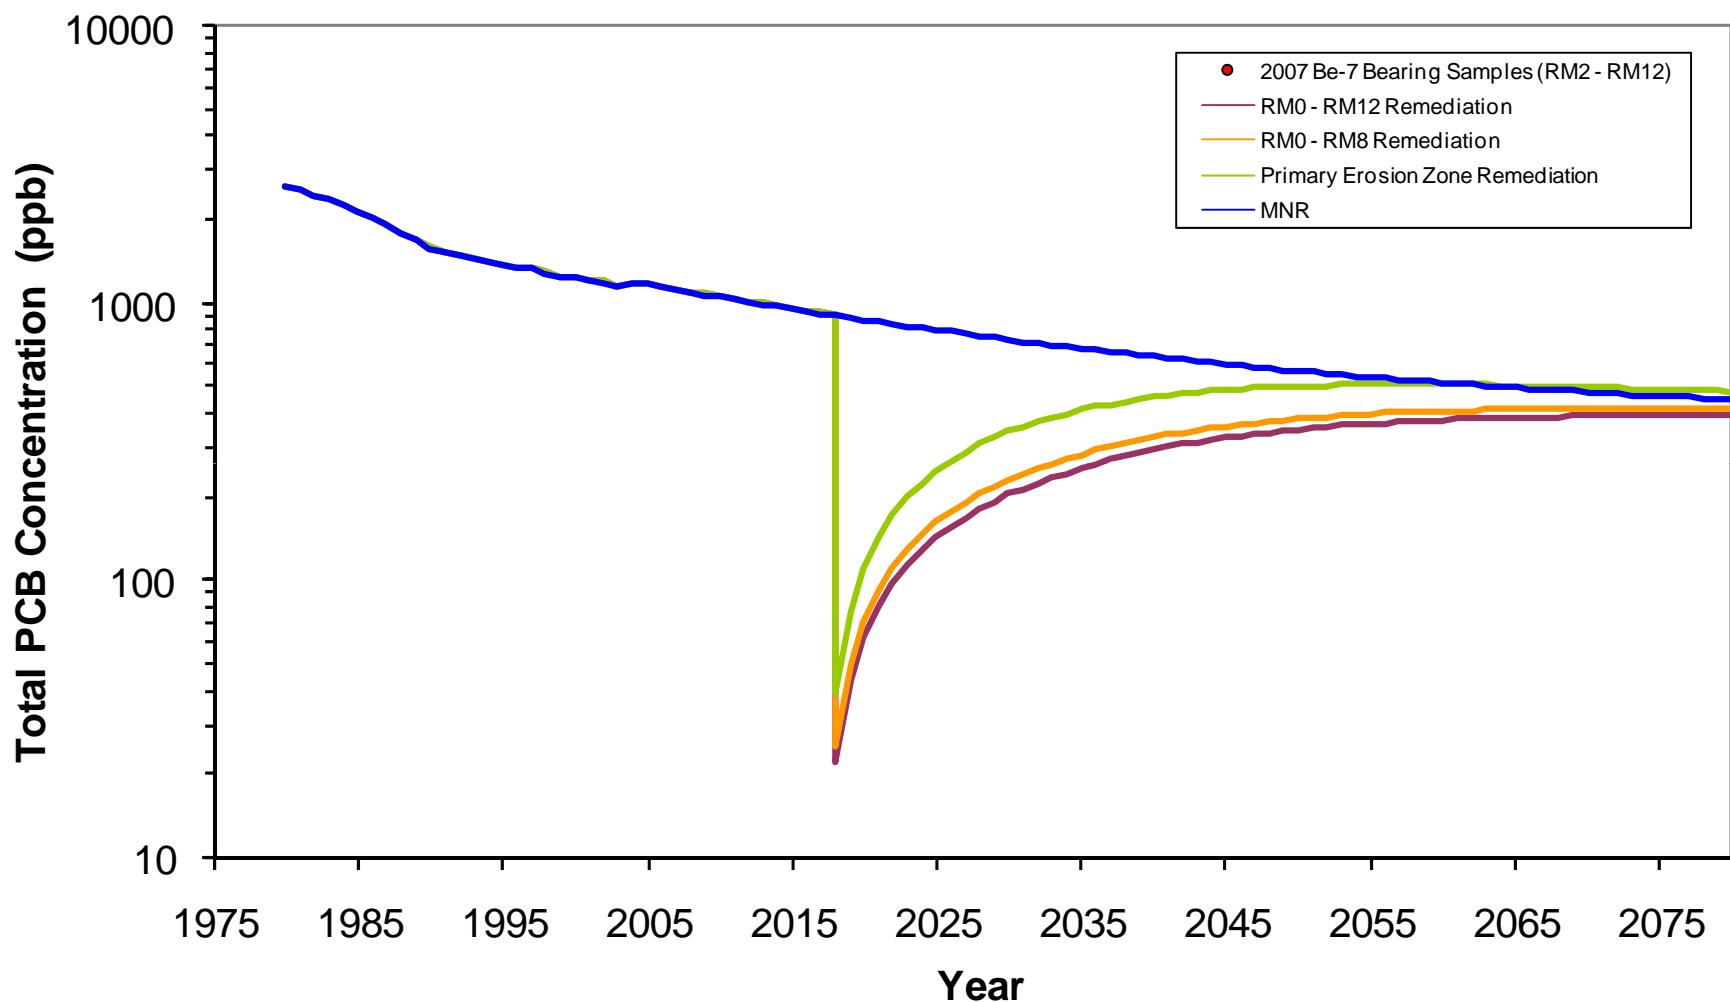
Figure 20-42

Total PCB
Comparison of Estimated Trajectories for Remediation Options for 0-6 inch
Biologically Active Layer in Capped Regions
Lower Passaic River Restoration Project

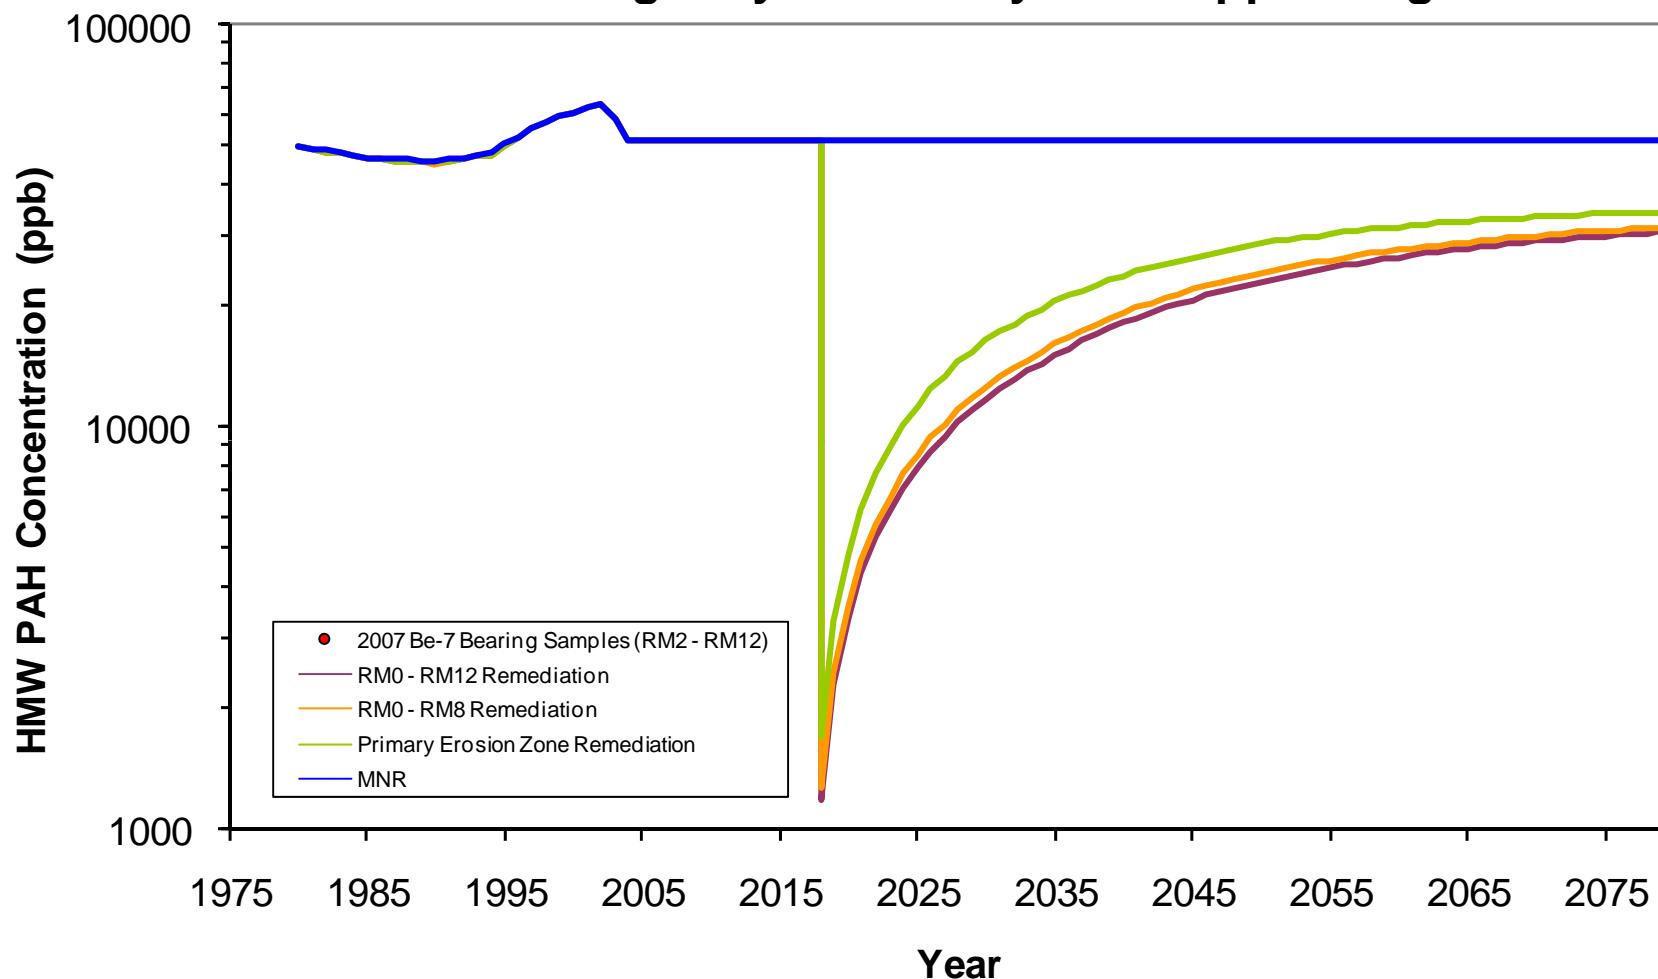
Figure 20-43

HMW PAH
Comparison of Estimated Trajectories for Remediation Options for 0-6 inch
Biologically Active Layer in Capped Regions
Lower Passaic River Restoration Project

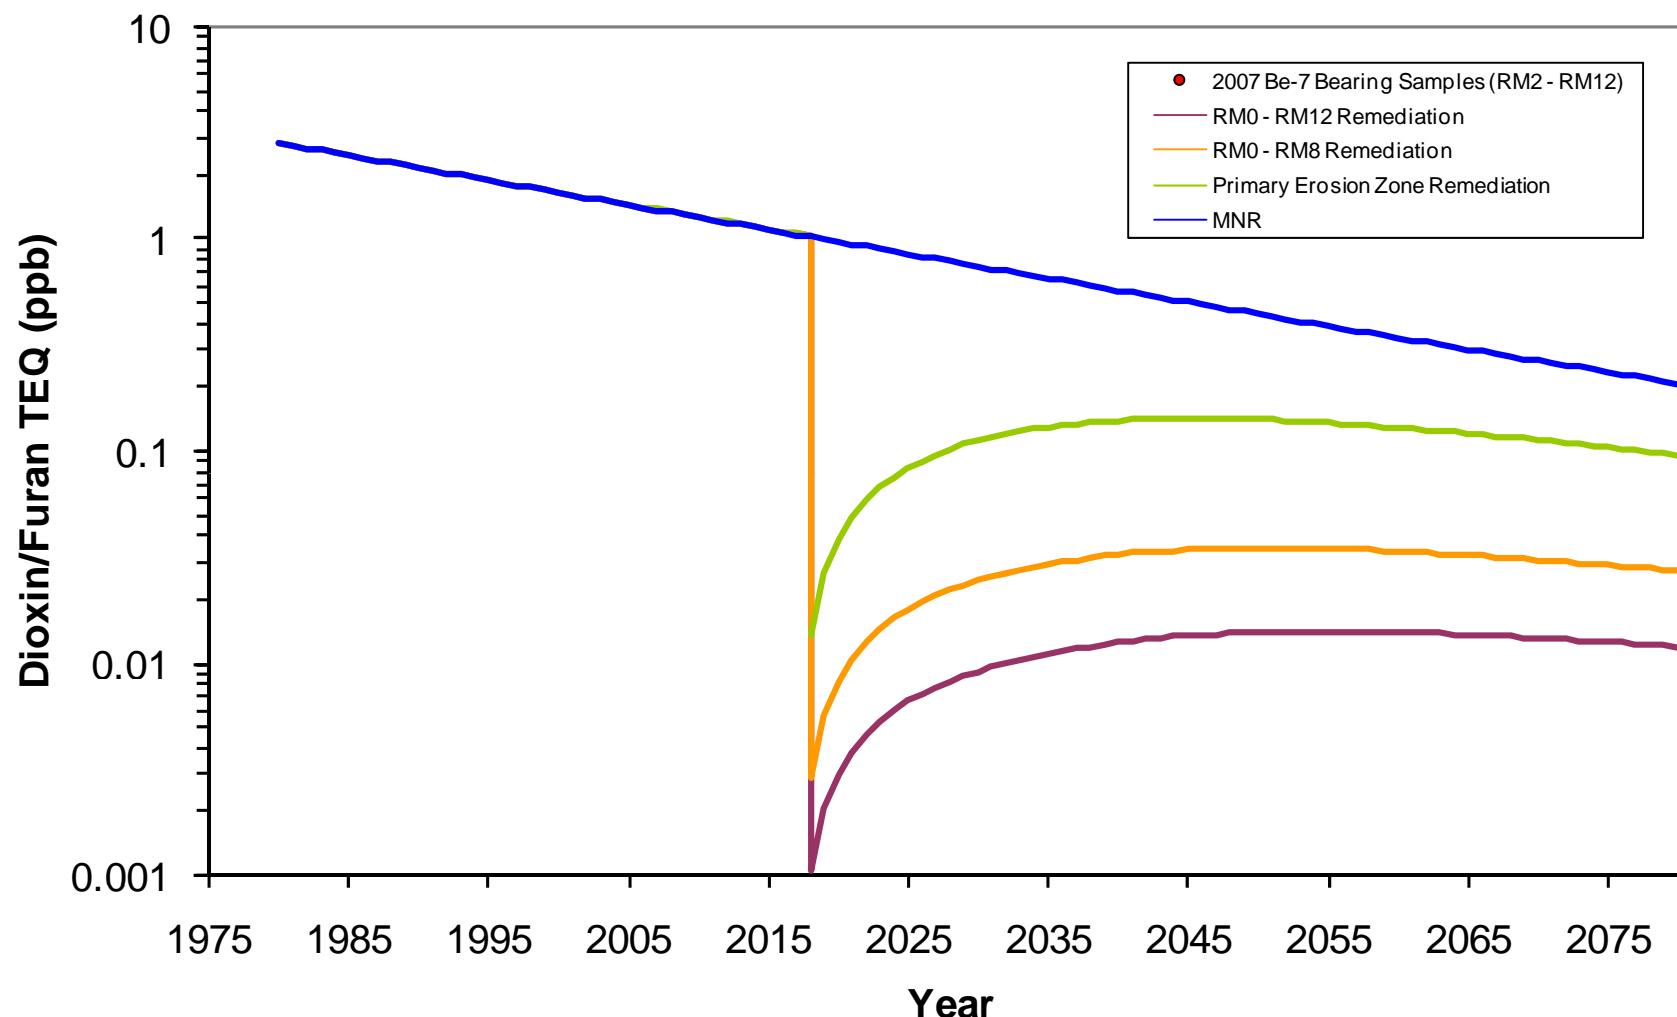
Figure 20-44

Dioxin/Furan TEQ (Fish)
Comparison of Estimated Trajectories for Remediation Options for 0-6 inch
Biologically Active Layer in Capped Regions
Lower Passaic River Restoration Project

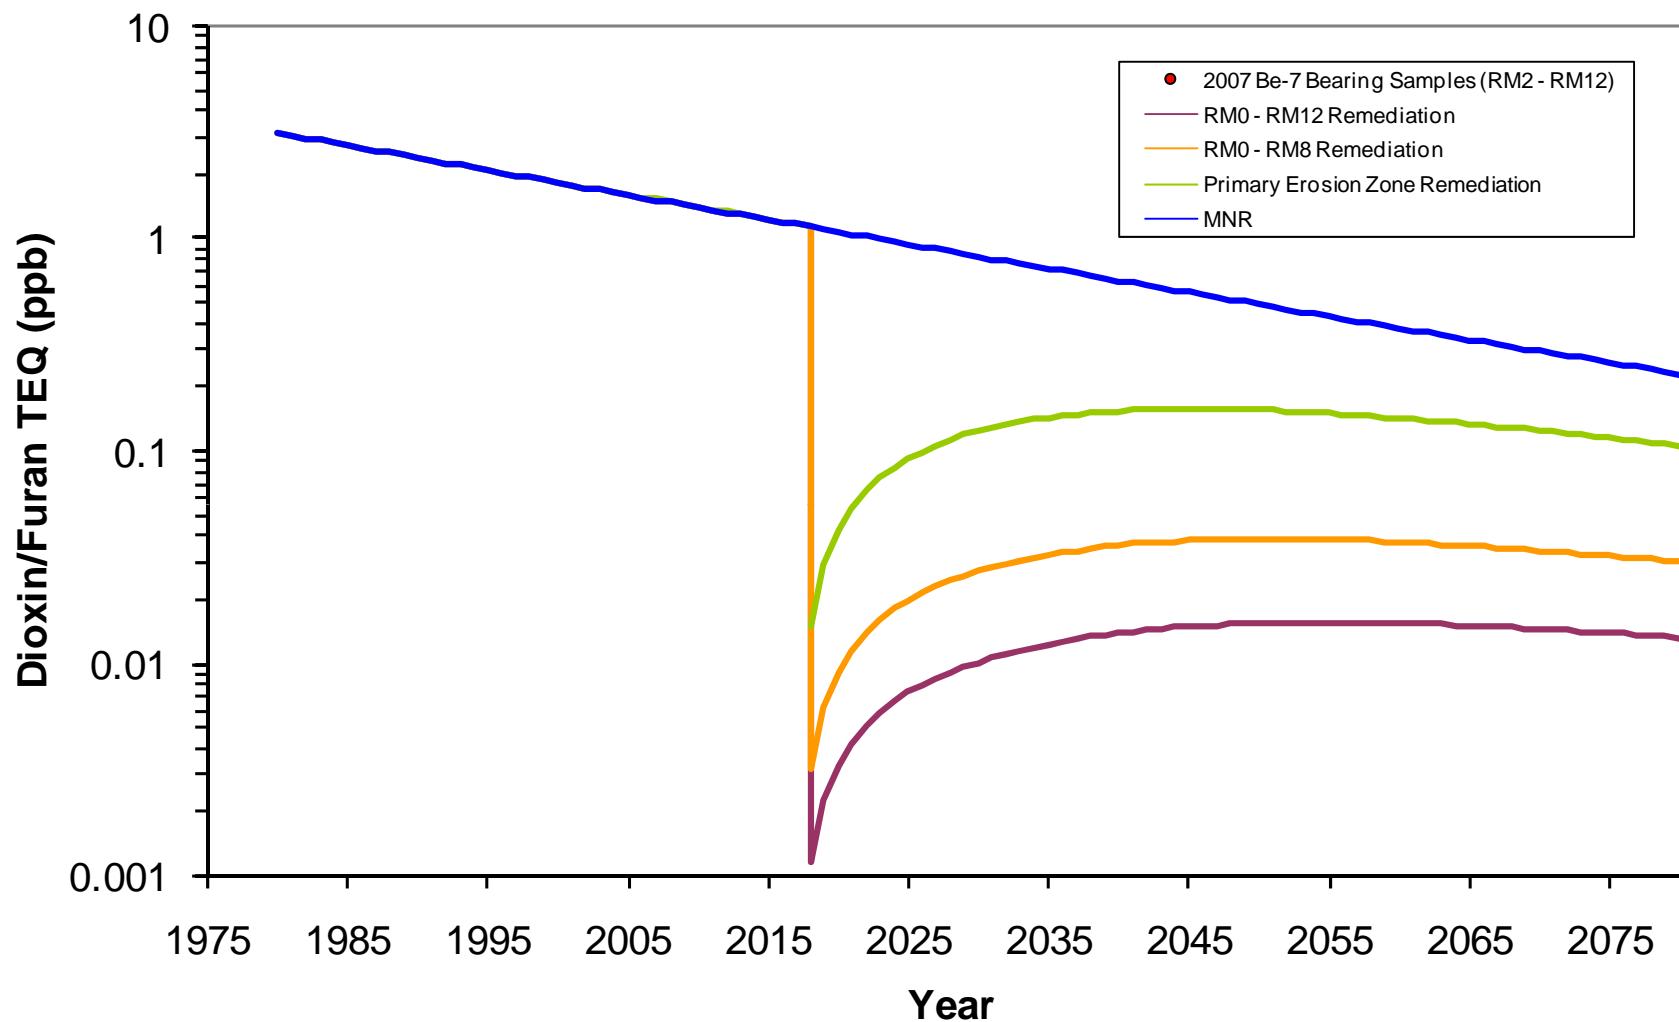
Figure 20-45

Dioxin/Furan TEQ (Bird)
Comparison of Estimated Trajectories for Remediation Options for 0-6 inch
Biologically Active Layer in Capped Regions
Lower Passaic River Restoration Project

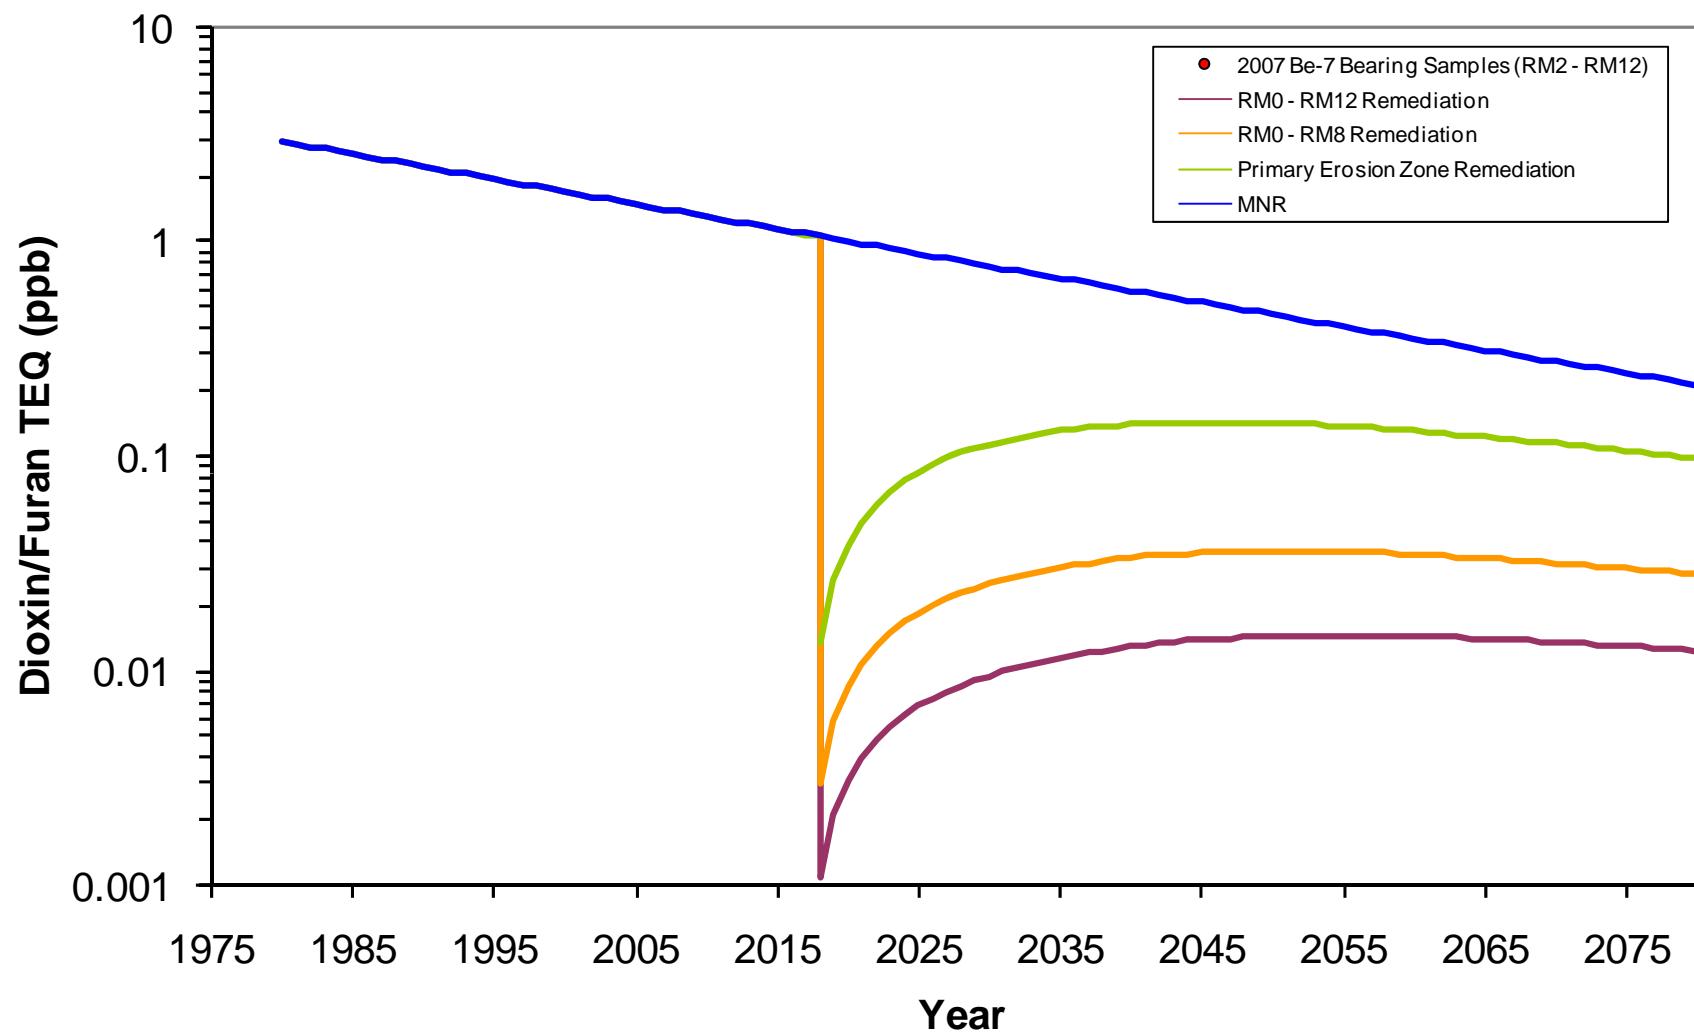
Figure 20-46

Dioxin/Furan TEQ (Mammal)
Comparison of Estimated Trajectories for Remediation Options for 0-6 inch
Biologically Active Layer in Capped Regions
Lower Passaic River Restoration Project

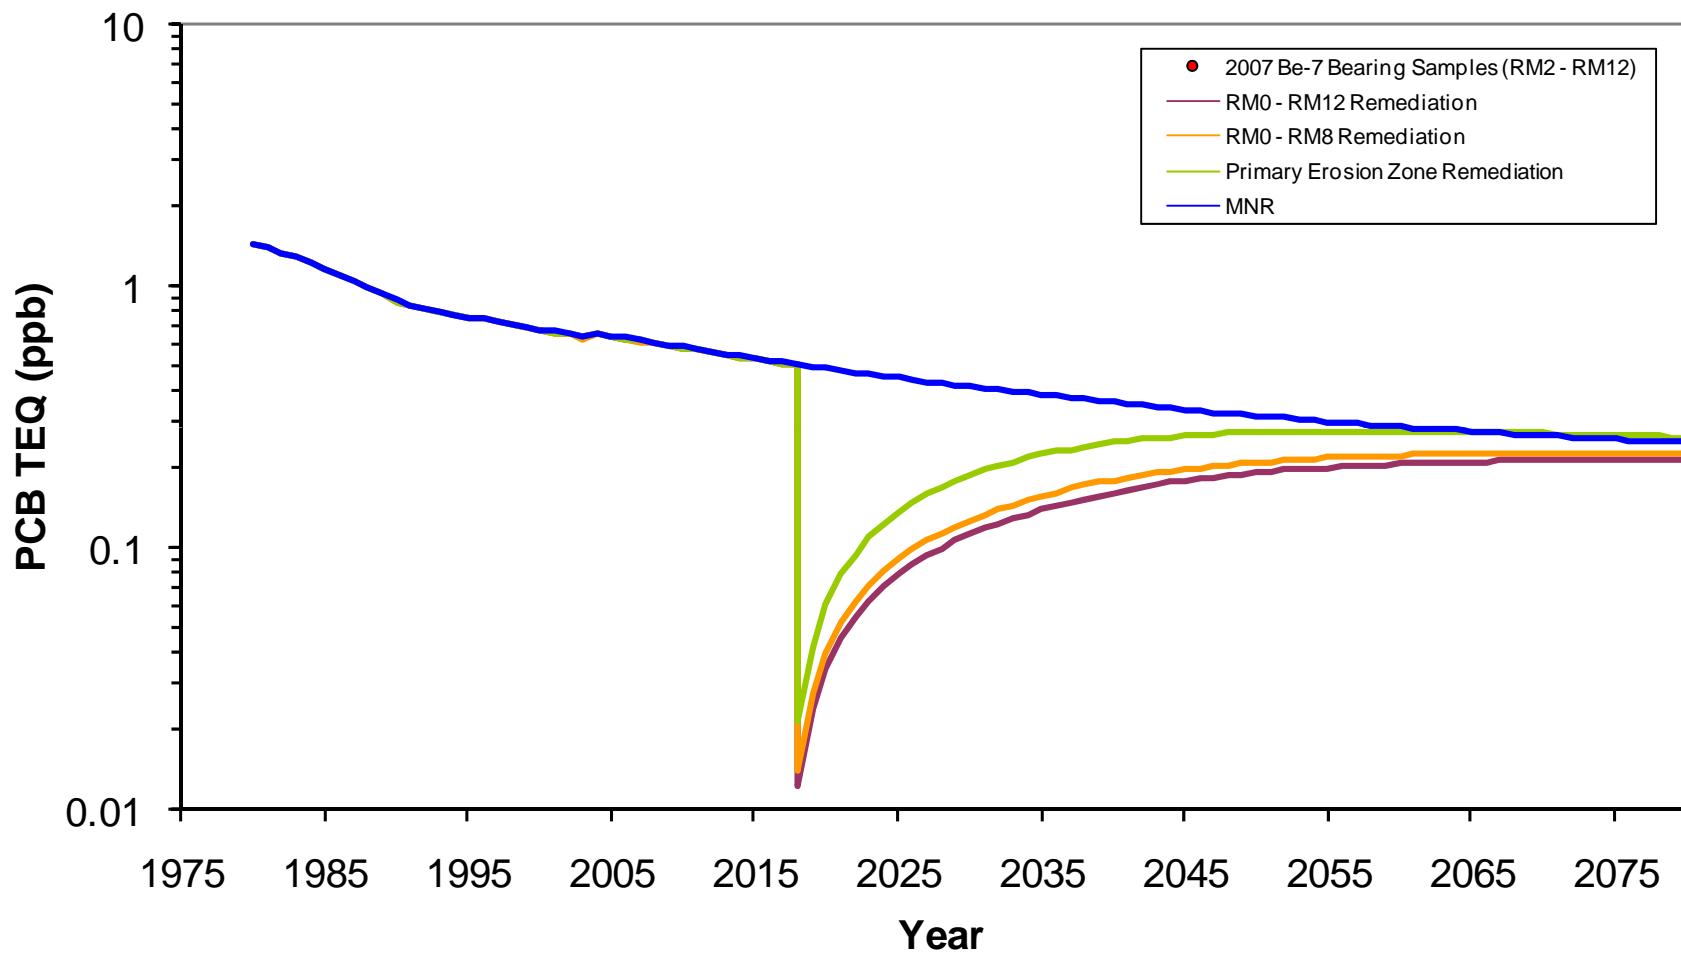
Figure 20-47

PCB TEQ (Fish)
Comparison of Estimated Trajectories for Remediation Options for 0-6 inch
Biologically Active Layer in Capped Regions
Lower Passaic River Restoration Project

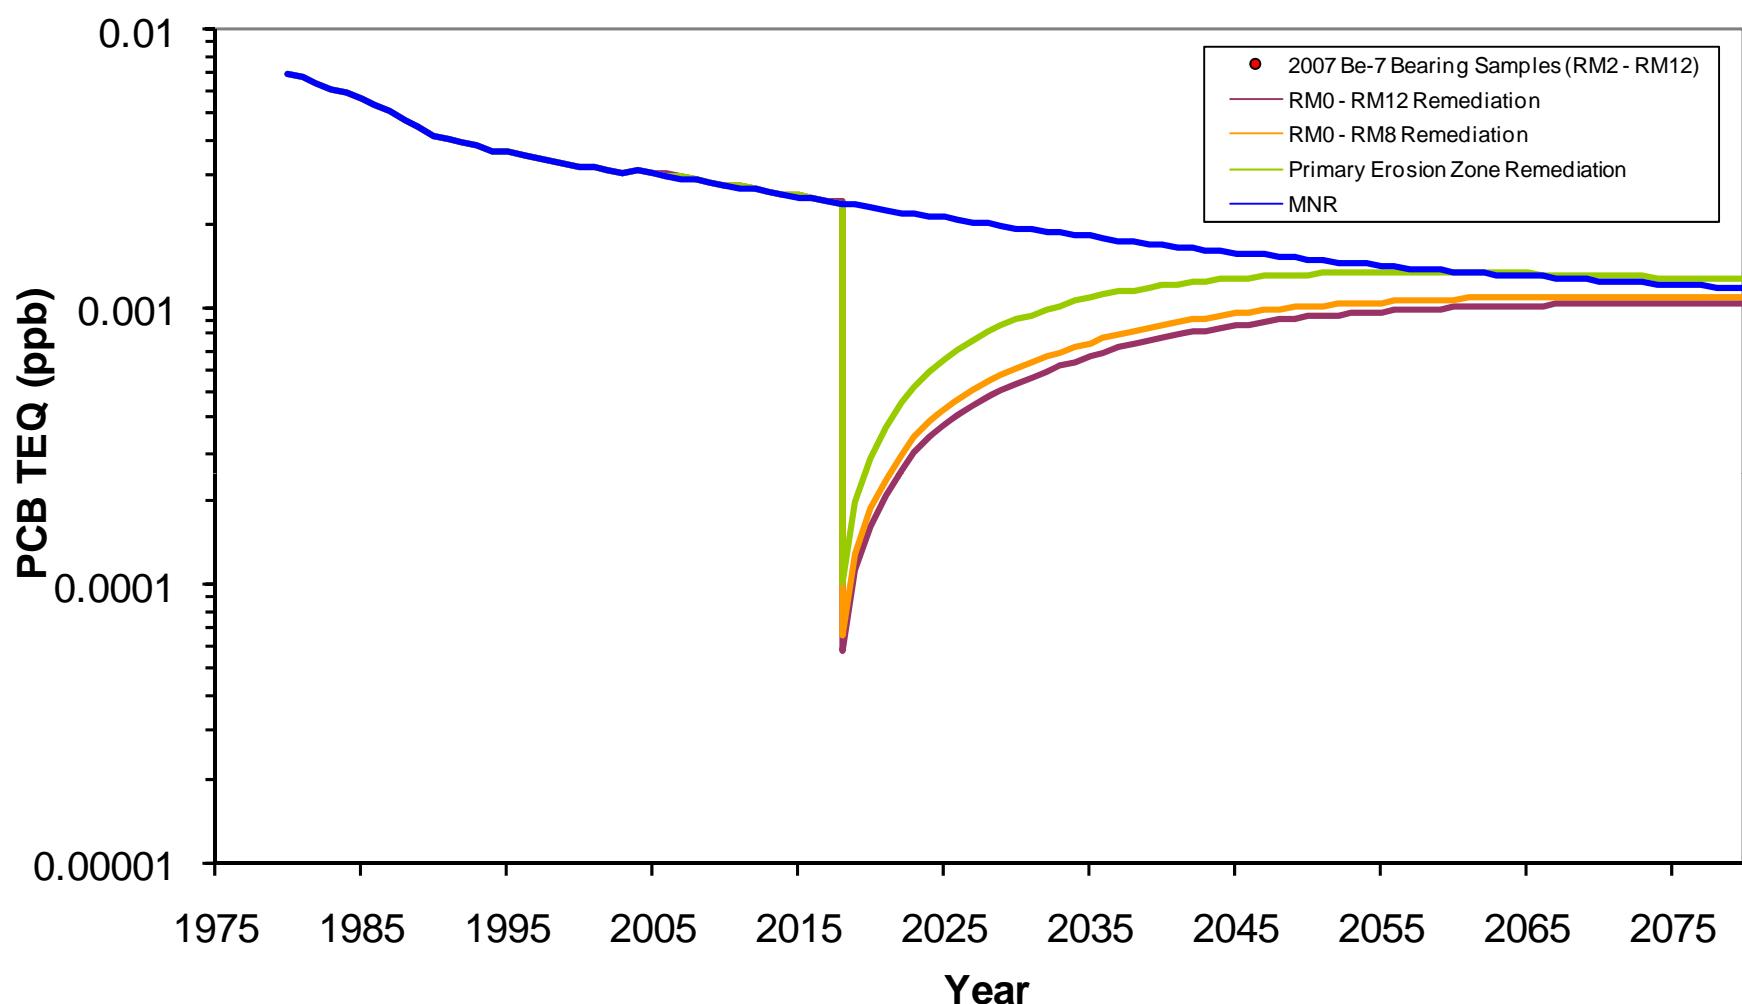
Figure 20-48

PCB TEQ (Bird)
Comparison of Estimated Trajectories for Remediation Options for 0-6 inch
Biologically Active Layer in Capped Regions
Lower Passaic River Restoration Project

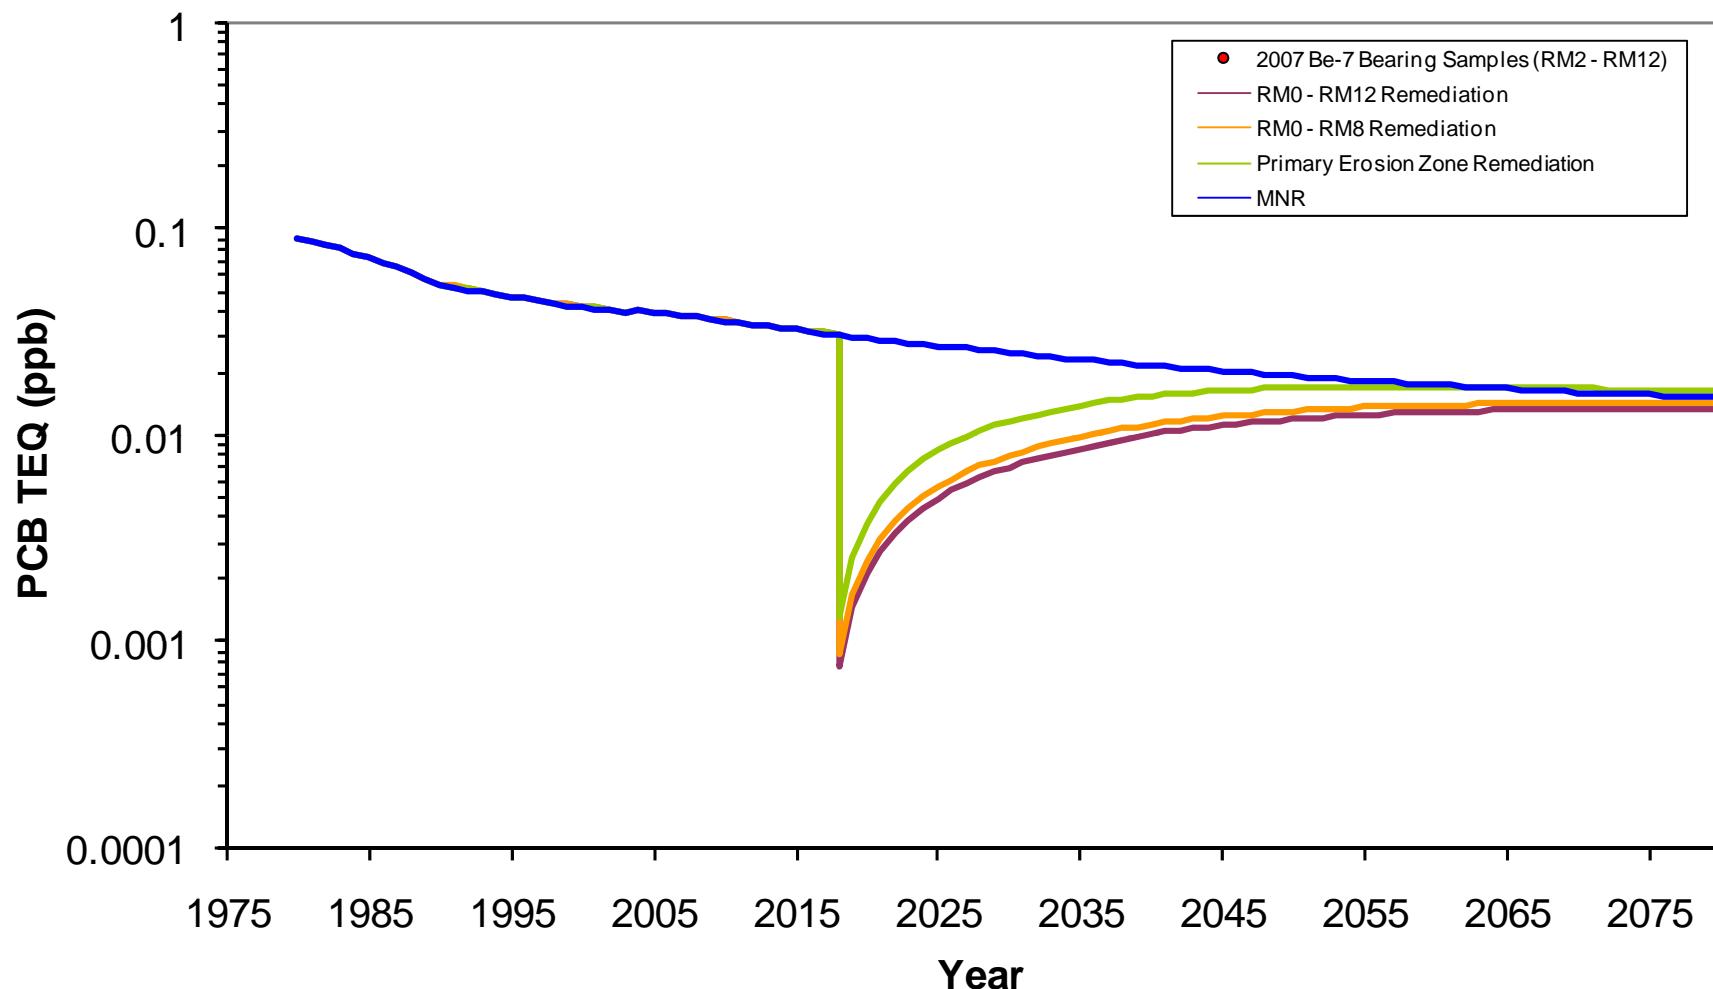
Figure 20-49

PCB TEQ (Mammal)
Comparison of Estimated Trajectories for Remediation Options for 0-6 inch
Biologically Active Layer in Capped Regions
Lower Passaic River Restoration Project

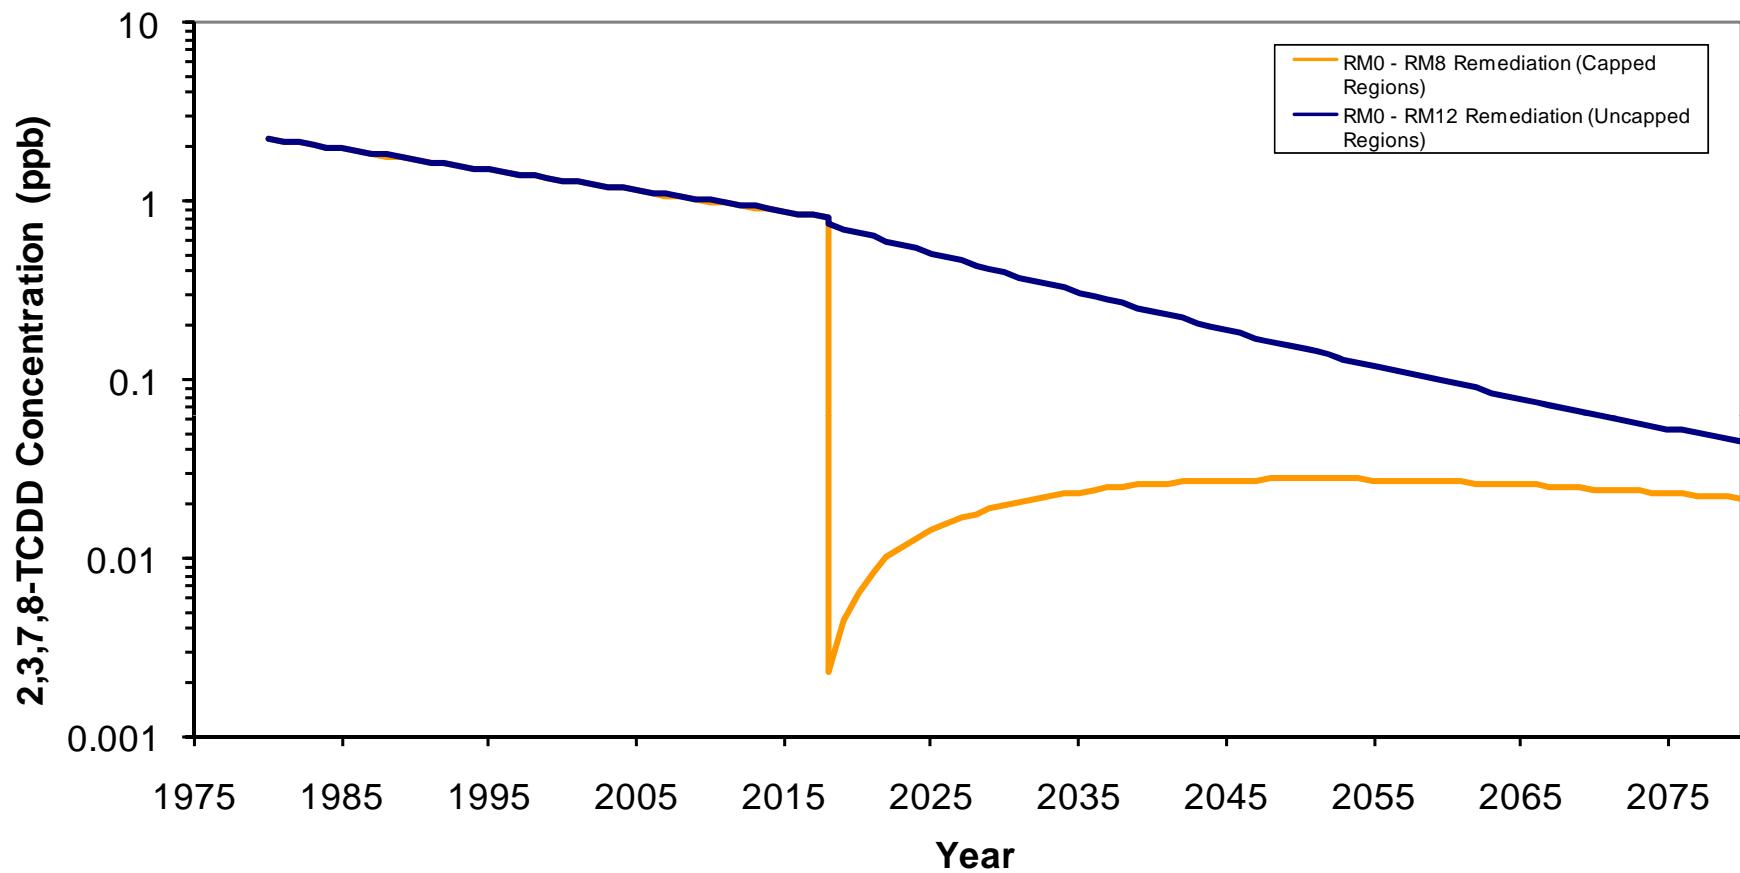
Figure 20-50

2,3,7,8-TCDD
Comparison of Estimated Trajectories in Capped and Uncapped Regions for 0-
6 inch Biologically Active Layer after Capping and Dredging RM0 - RM8
Lower Passaic River Restoration Project

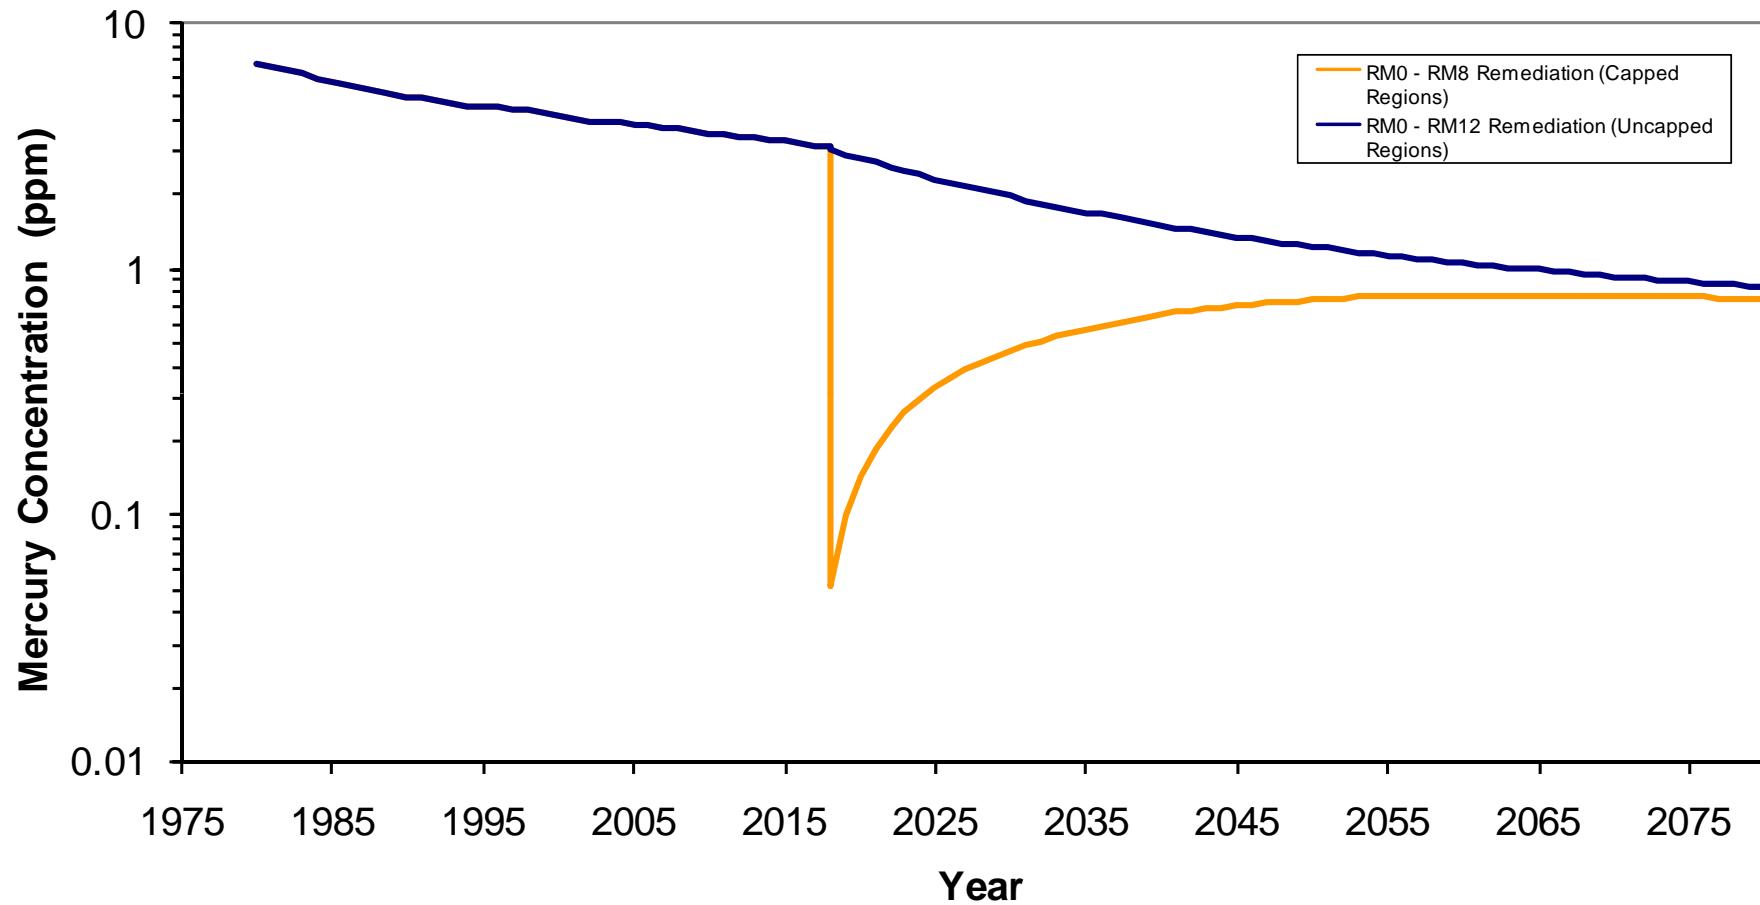
Figure 20-51

Mercury
Comparison of Estimated Trajectories in Capped and Uncapped Regions for 0-
6 inch Biologically Active Layer after Capping and Dredging RM0 - RM8
Lower Passaic River Restoration Project

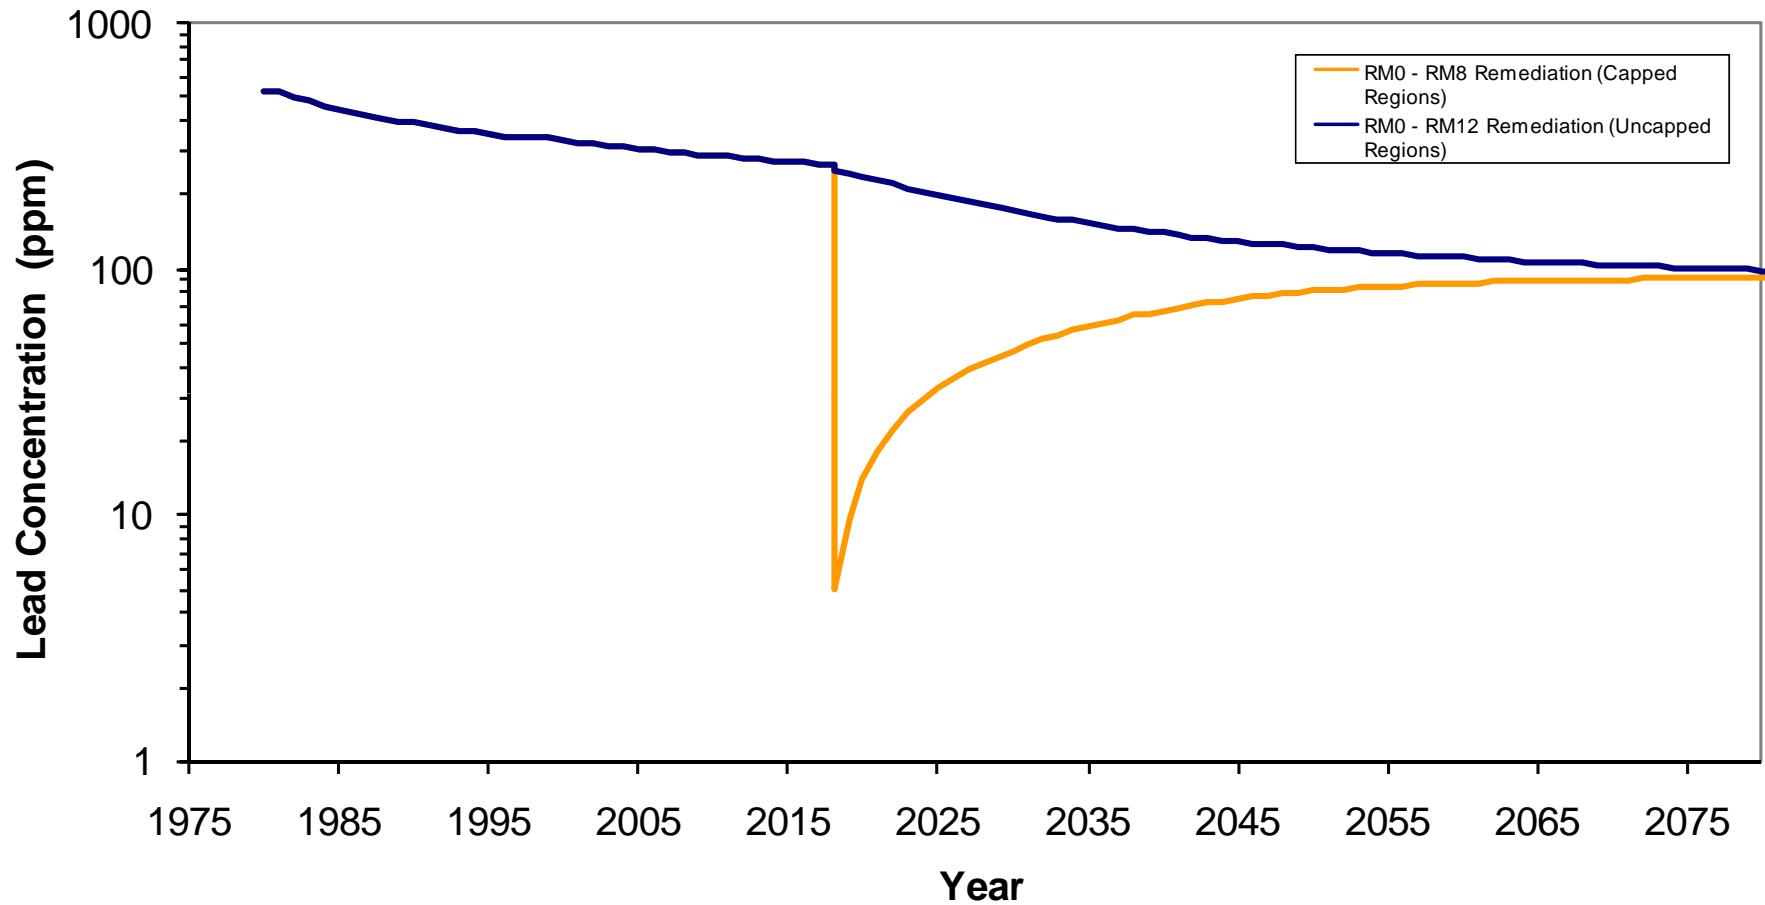
Figure 20-52

Lead
Comparison of Estimated Trajectories in Capped and Uncapped Regions for 0-6 inch Biologically Active Layer after Capping and Dredging RM0 - RM8
Lower Passaic River Restoration Project
